Water Main Replacement Work A Field Example

July/August 2012

Miguel A. Del Toral

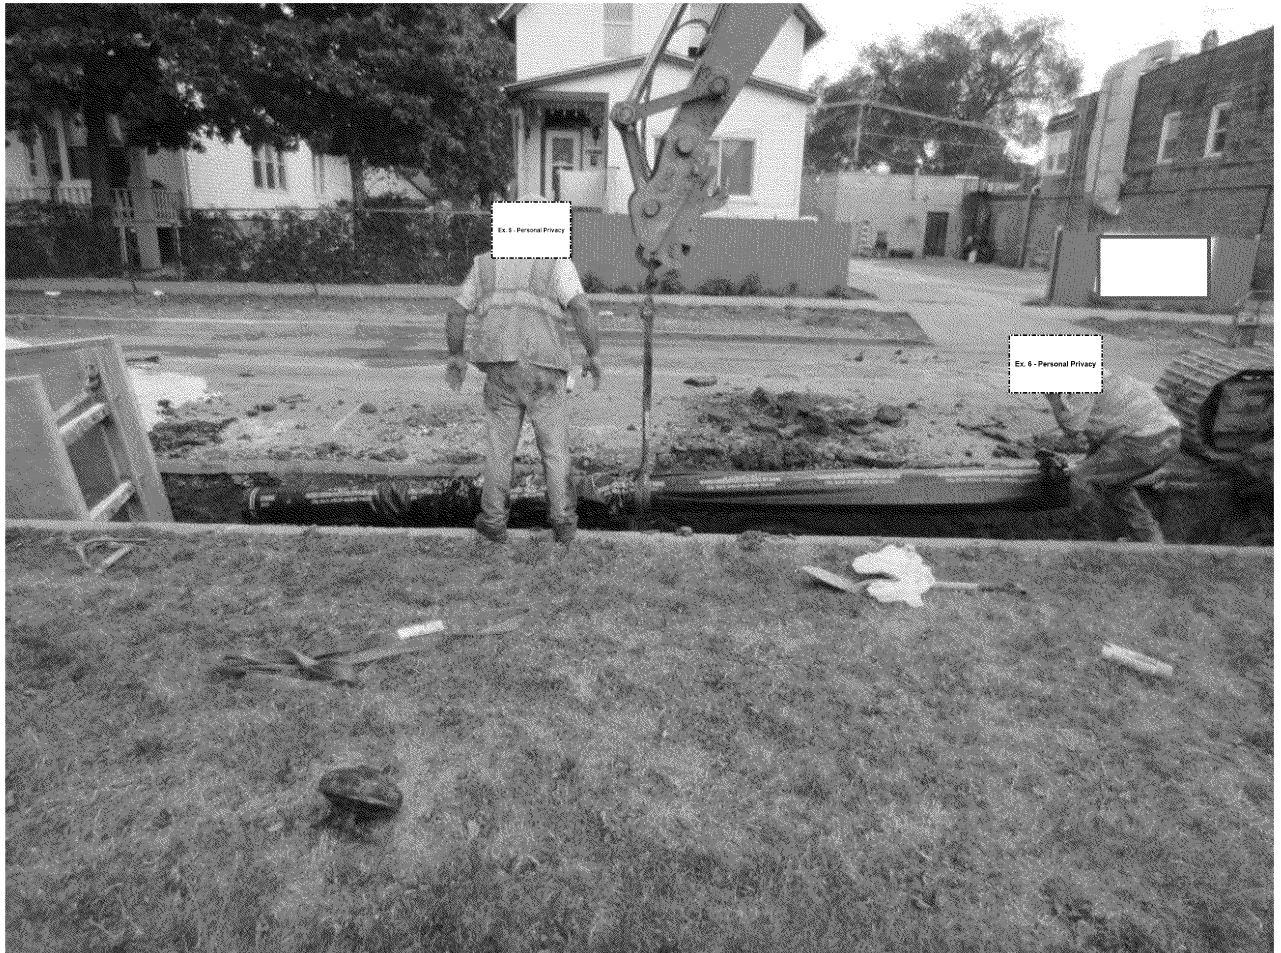
A trench is dug along the curb for the new water main.
After digging the trench the new water main is lowered in place.

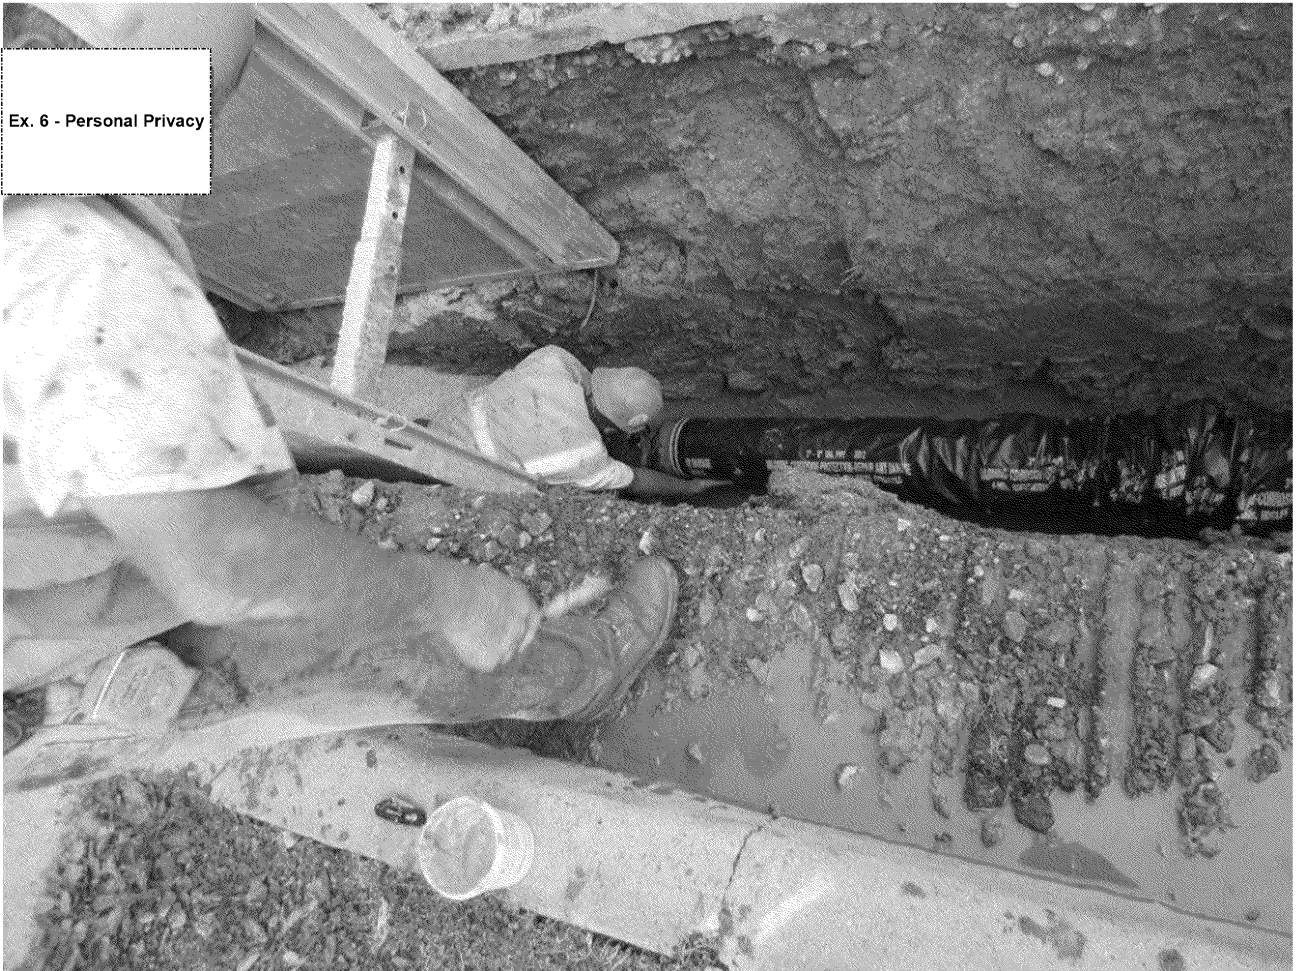
Once the new main is placed, it is connected (being done here) and the trench is buried with gravel temporarily.

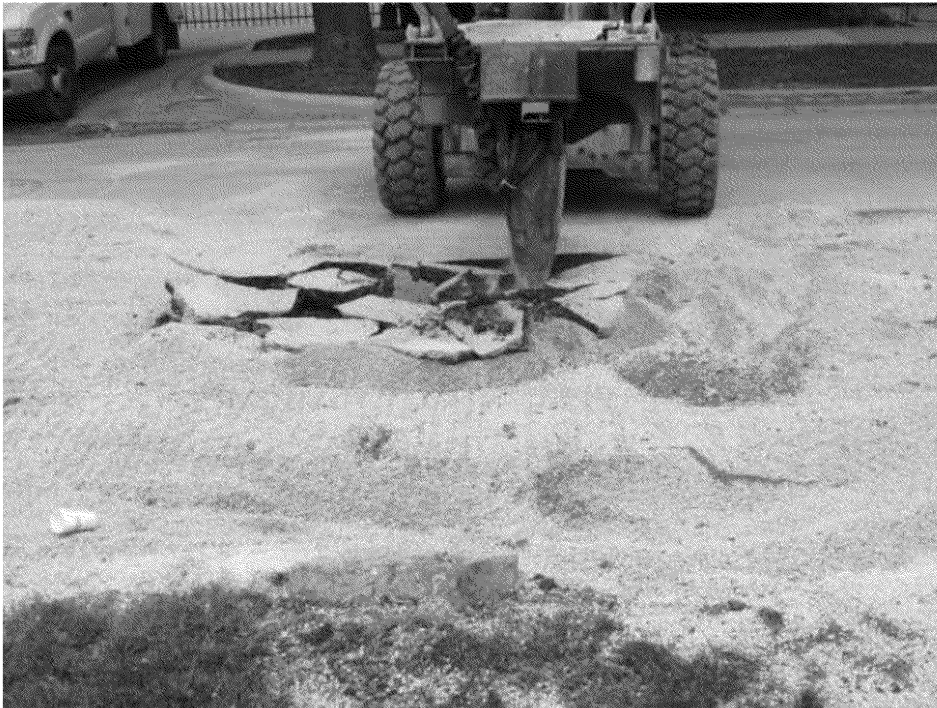
After they have installed the new main along the entire block, the water in the new main is shock-chlorinated (using concentrated chlorine). Once the bacteriological tests come back clean, they start excavating again to disconnect the lead service lines from the existing main and connecting them to the new main. The old main is next to the new one so they have to break up more street to get to service connections on the opposite side of the old water main which connect across the street.

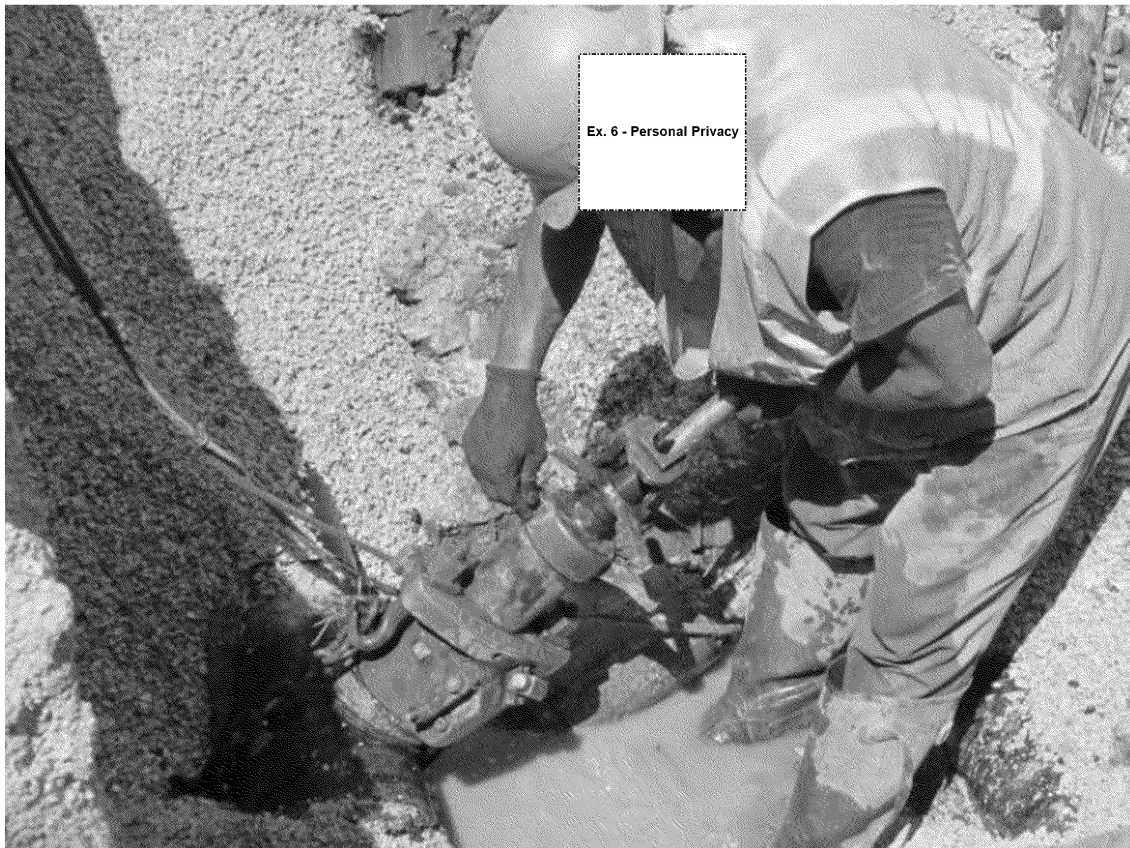
Once they dig out the gravel and uncover the new main again, they install a tap fitting using this machine, which drills a threaded hole into the new main, and then a threaded fitting (next pic) is installed using the same machine.

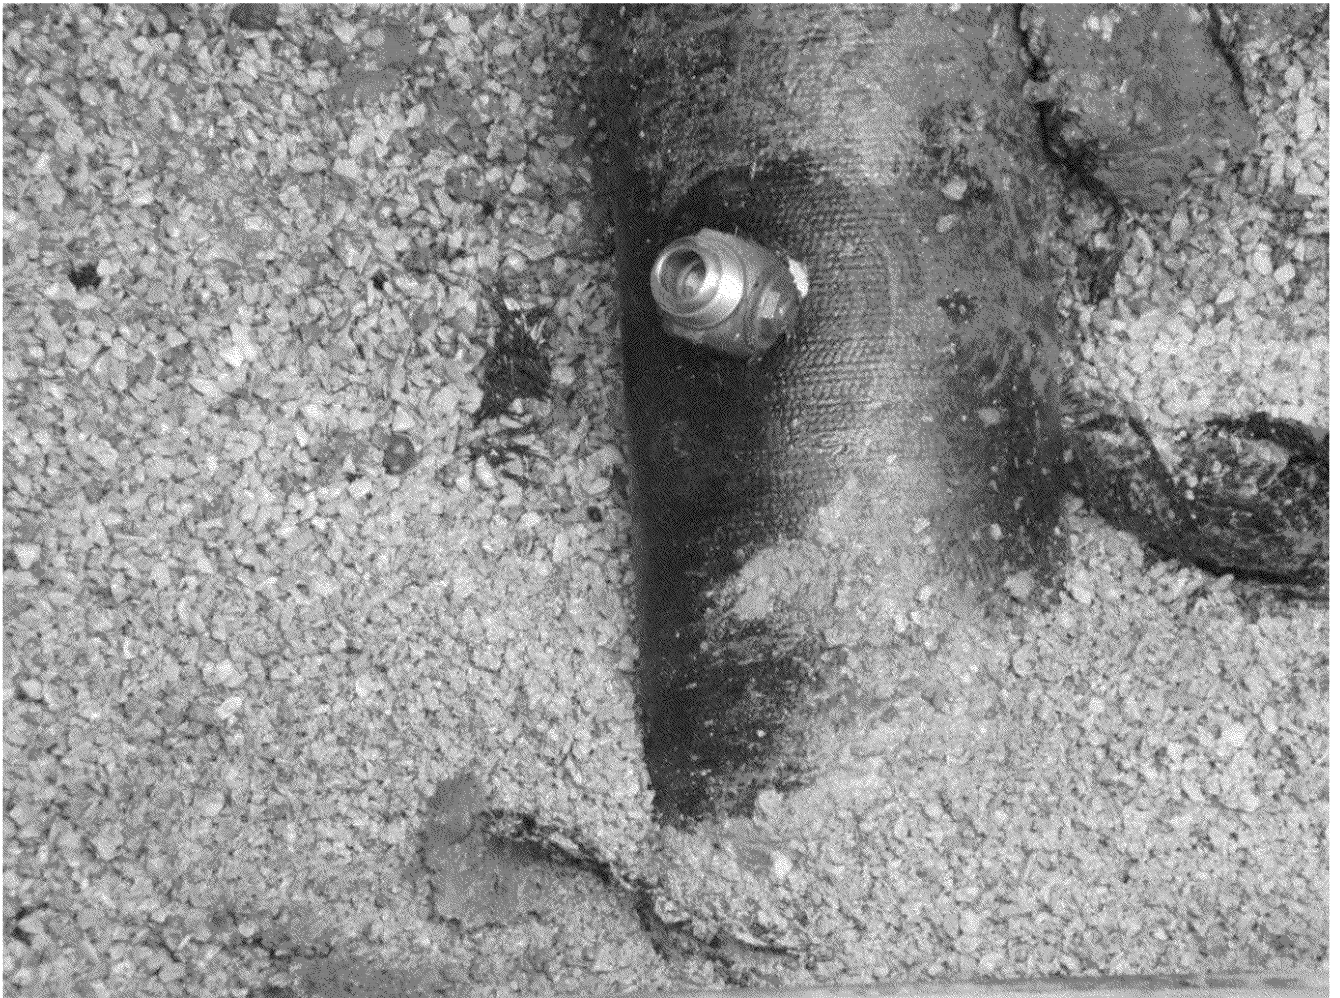
This is what the new fittings (main taps) look like.

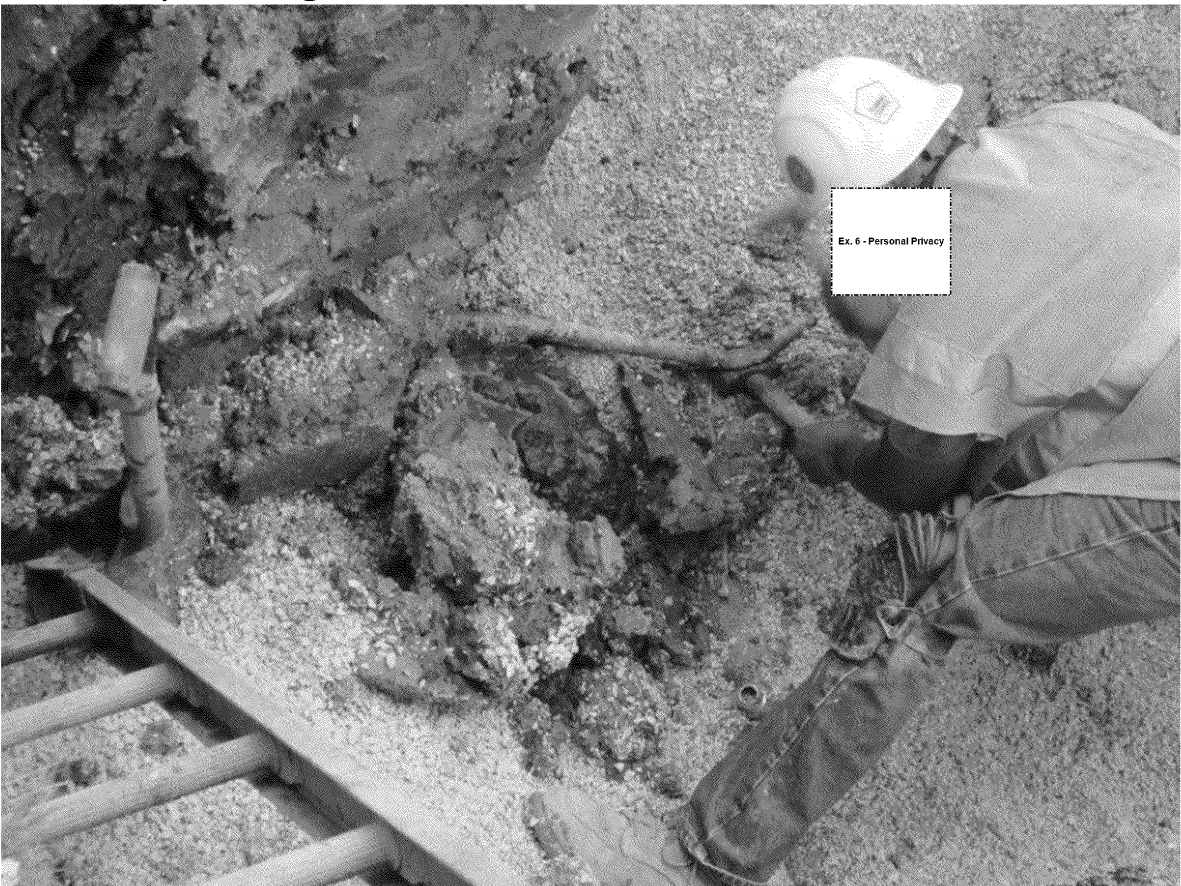
Next, because they can't get to the service shut-off valve on the old water main, two 2-lb hammers are used to pound the existing lead service line shut. Some utilities excavate to the old main and shut the water off by turning the shut-off valve.

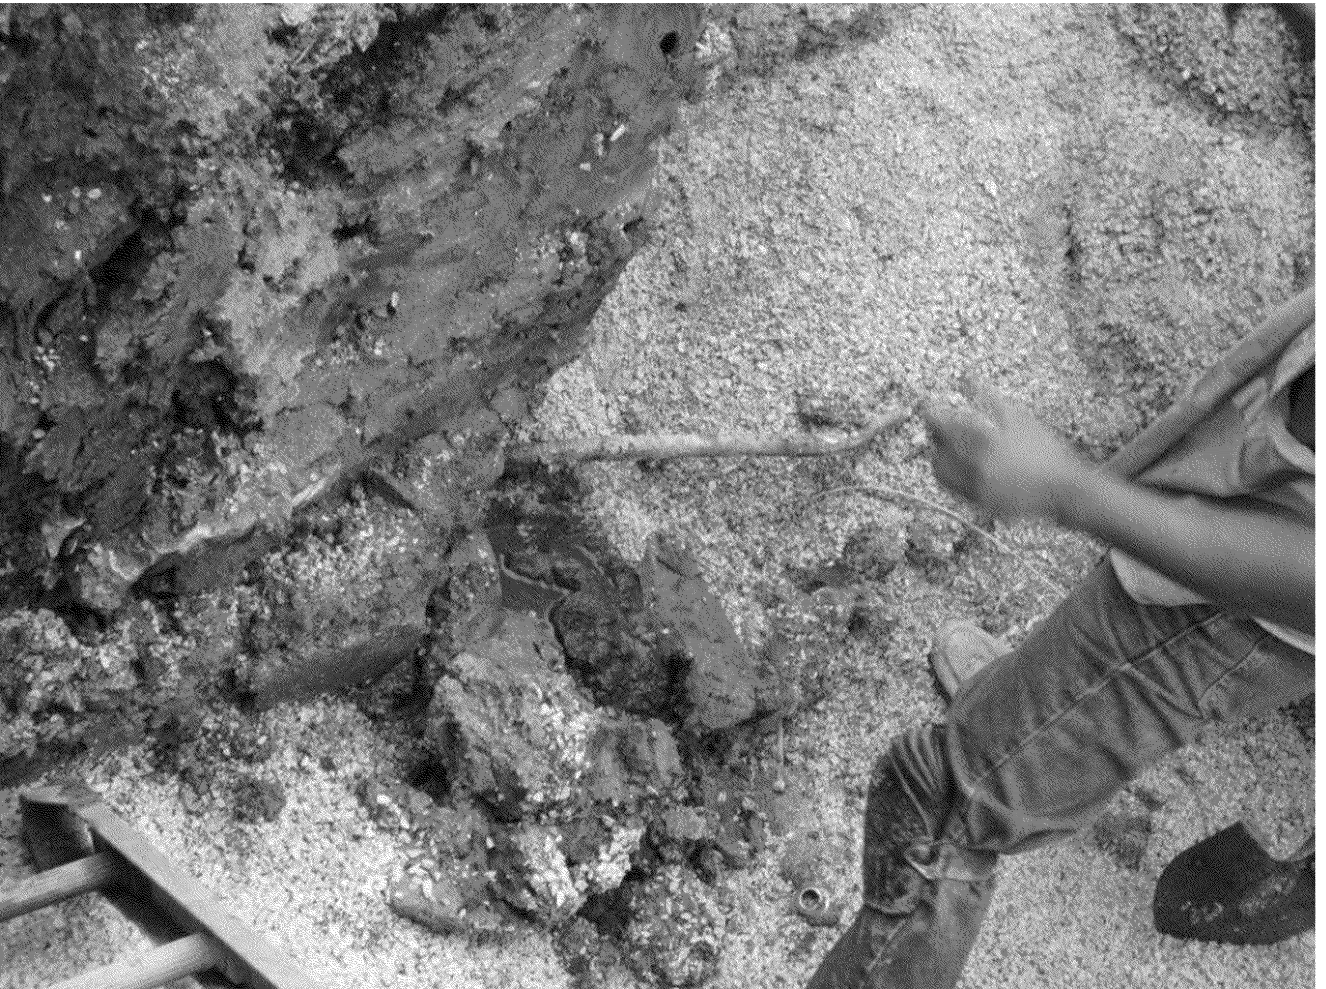
Once the lead pipe has been collapsed shut, they have to cut the lead pipe to be able to attach it to the new water main (nextpic)

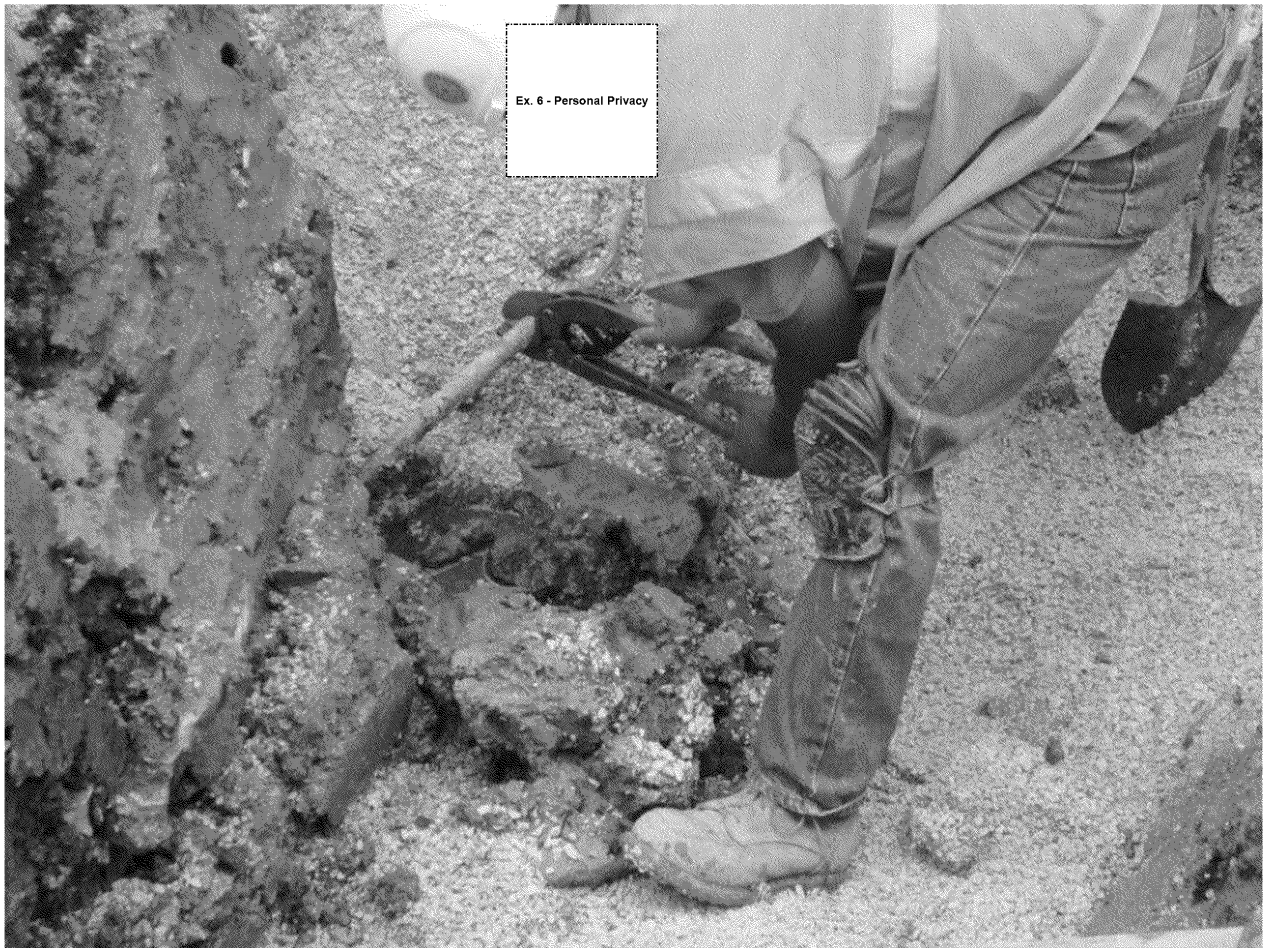
The lead service line is cut with snips. They cut partially, rotate it, cut more, rotate, etc., until they cut through it.

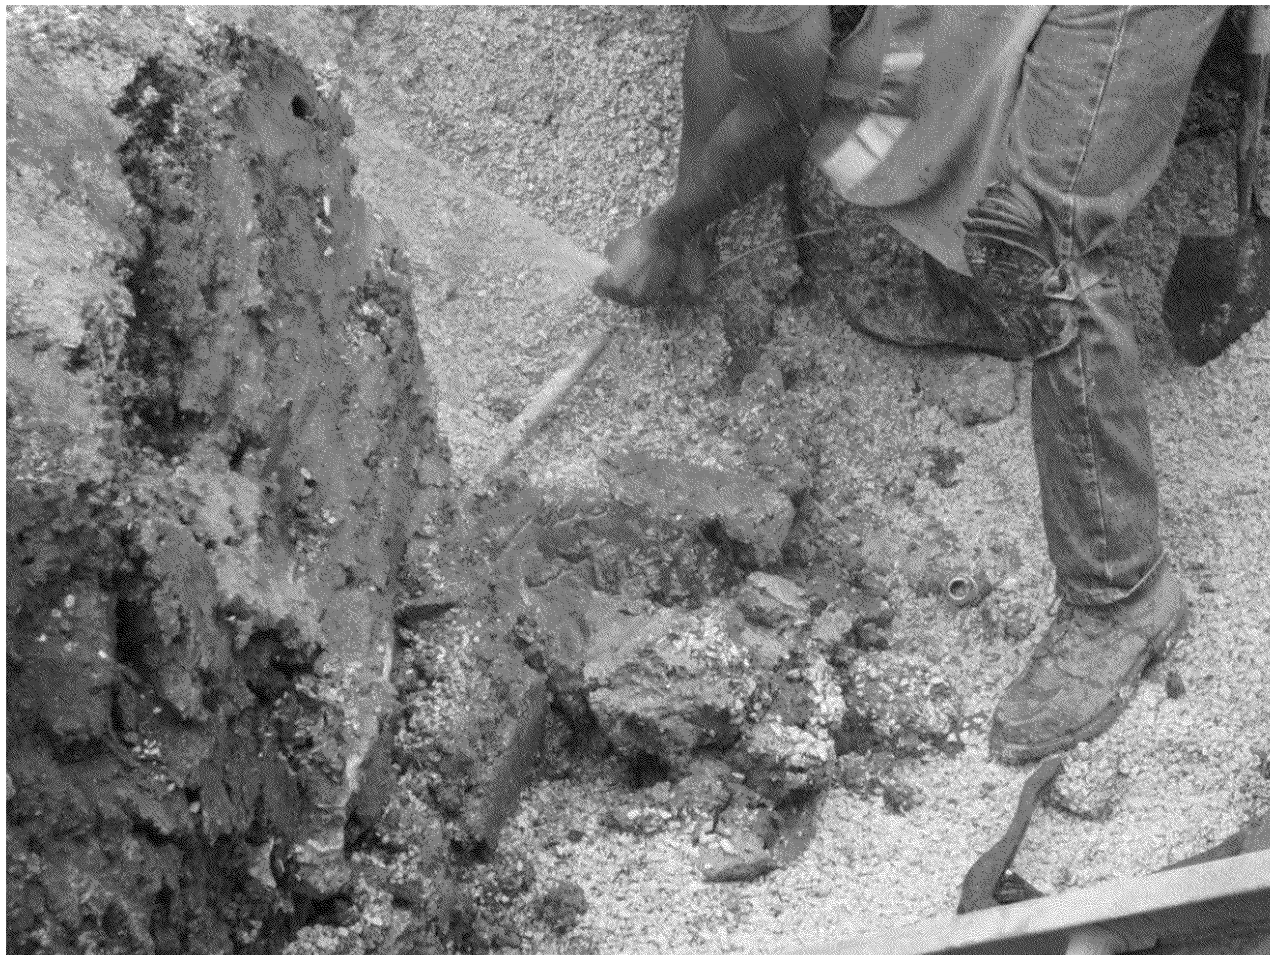
In this case the lead pipe was not completely collapsed, so water sprays from the pipe which is still connected to the old water main.

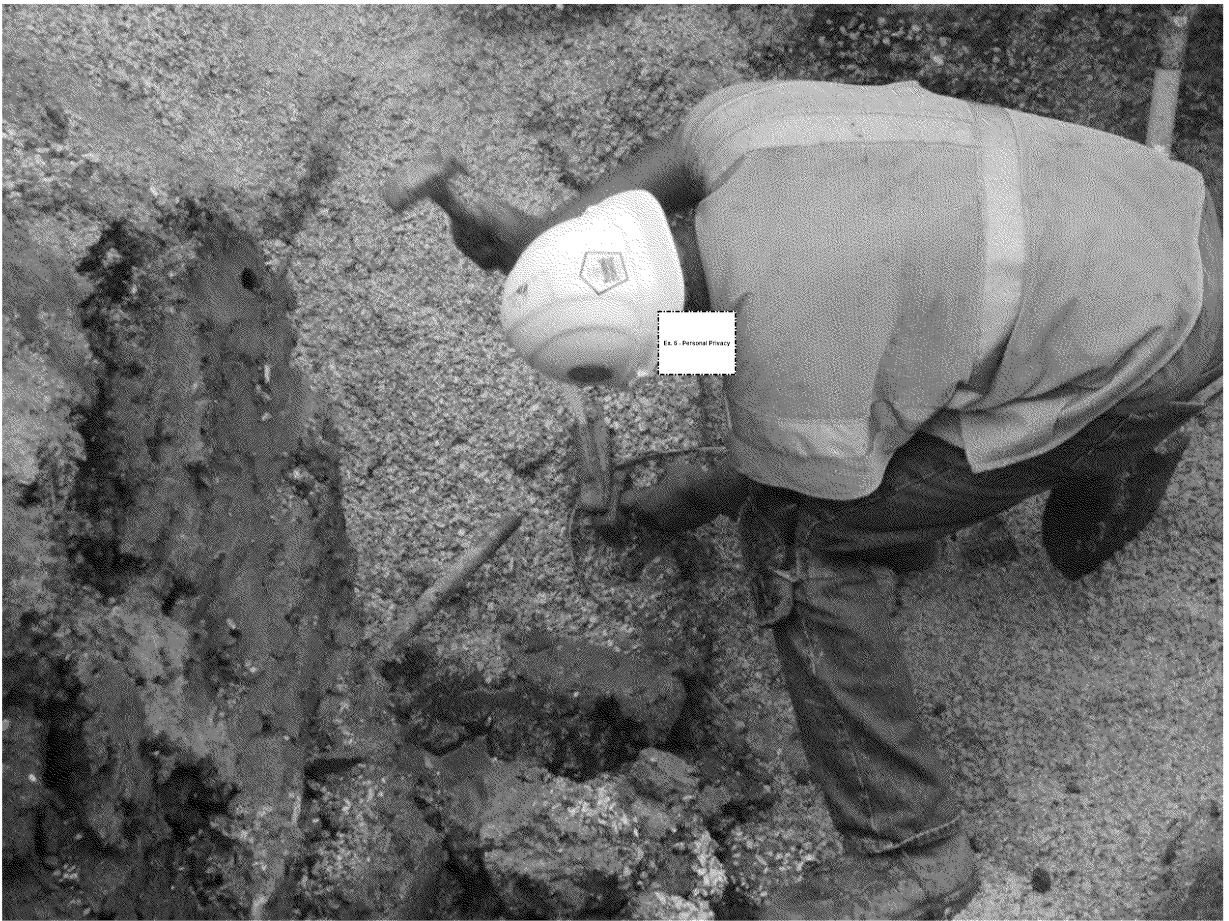
The lead pipe is pounded more to stop the water flow. Since the part of the lead pipe being pounded is connected to the old main, it is just pounded shut and left in place.

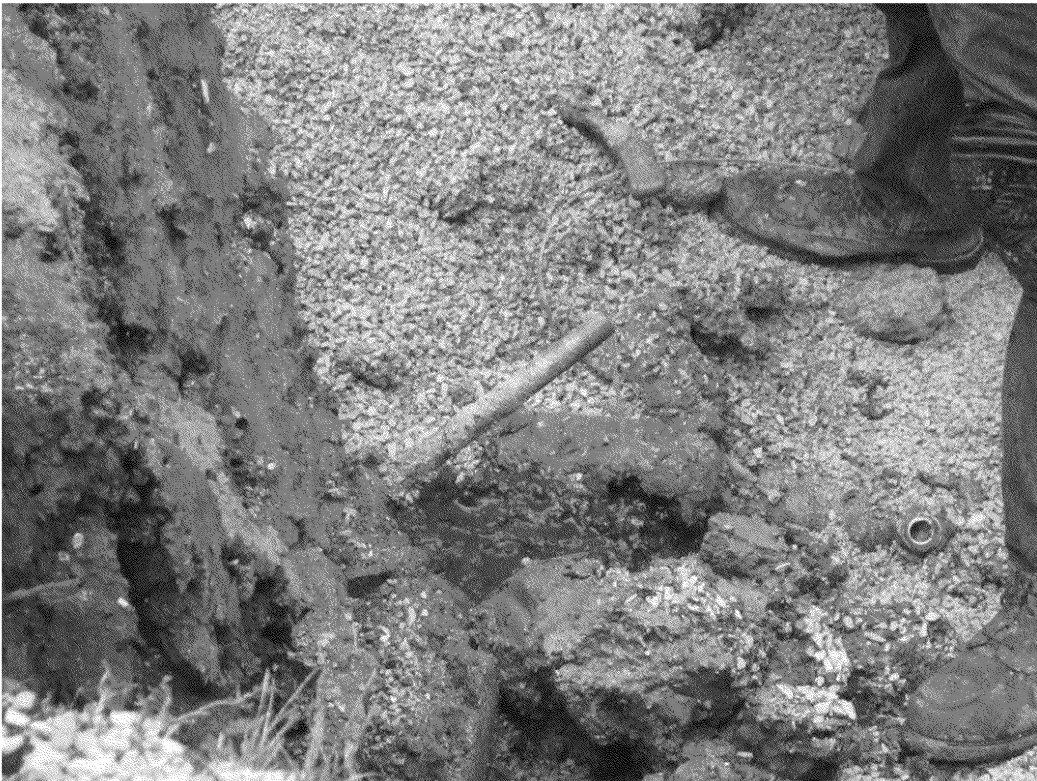
This is the remaining portion of the lead service line to the home, so they will attach this to the new main. Although the cut is clean, there is significant bending of the lead pipe to bring the edge out and also when connecting to the copper pipe. Lead is more flexible than copper, so they typically bend the lead pipe to make the connection.

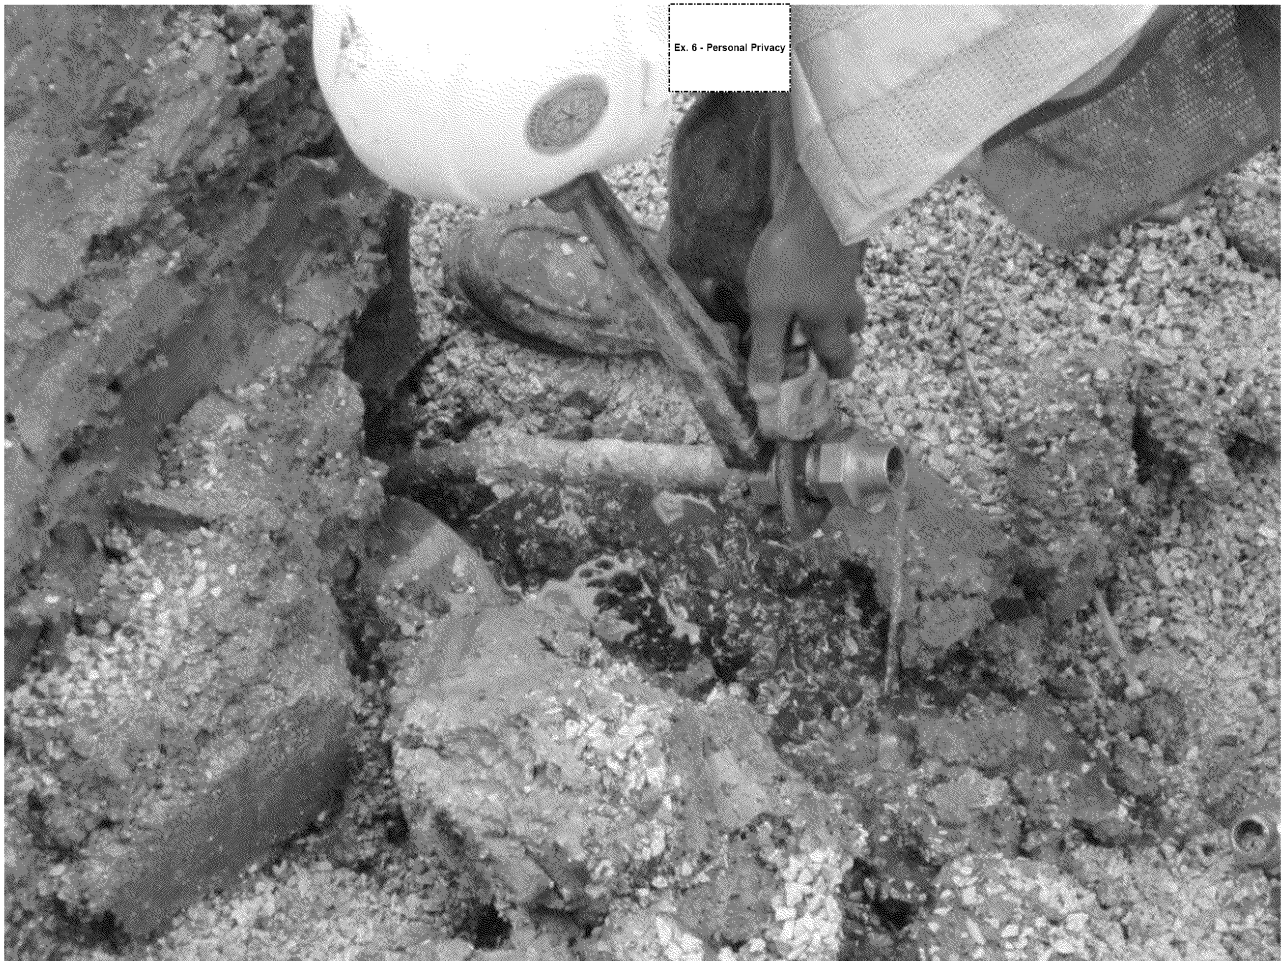
This is a bronze compression fitting being put on the LSL end.

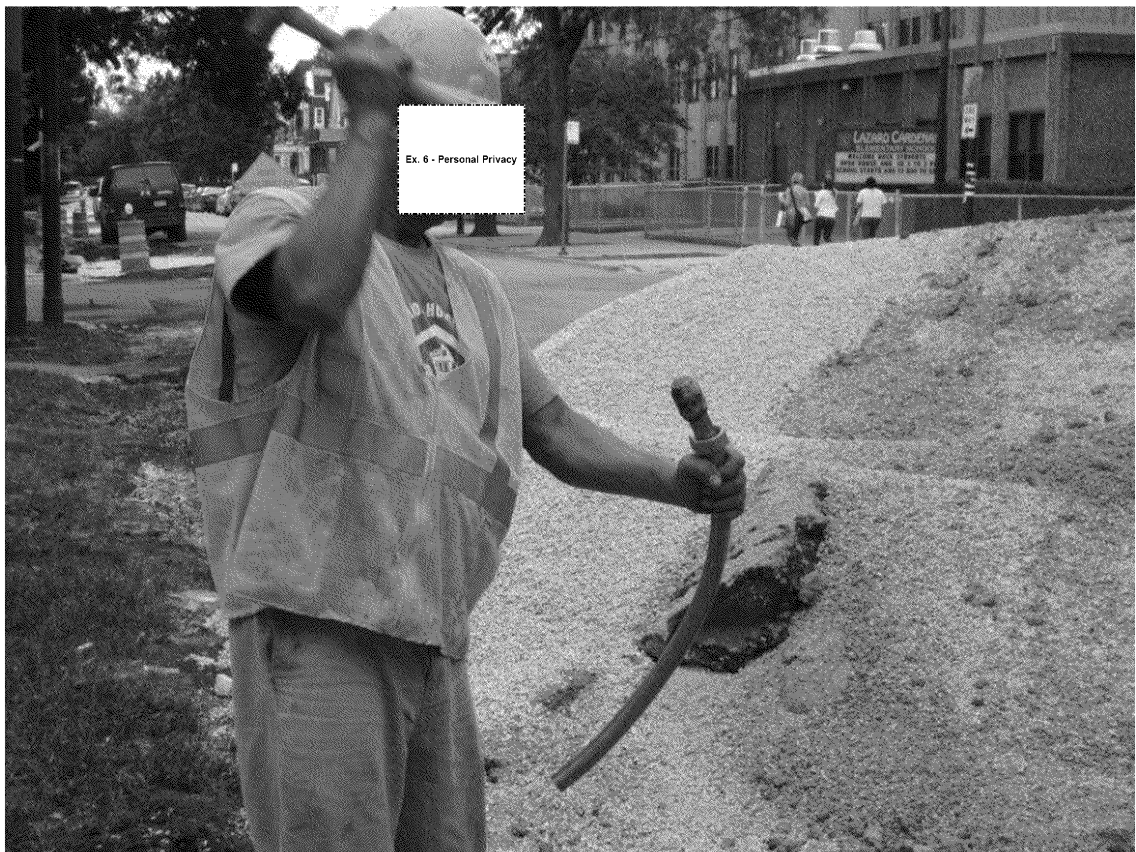
Segments of copper pipe are cut, and a coupling is slipped over the end of the pipe. A metal flaring tool is inserted to flare the end of the copper tube (next pic) so it does not slip out of the coupling.

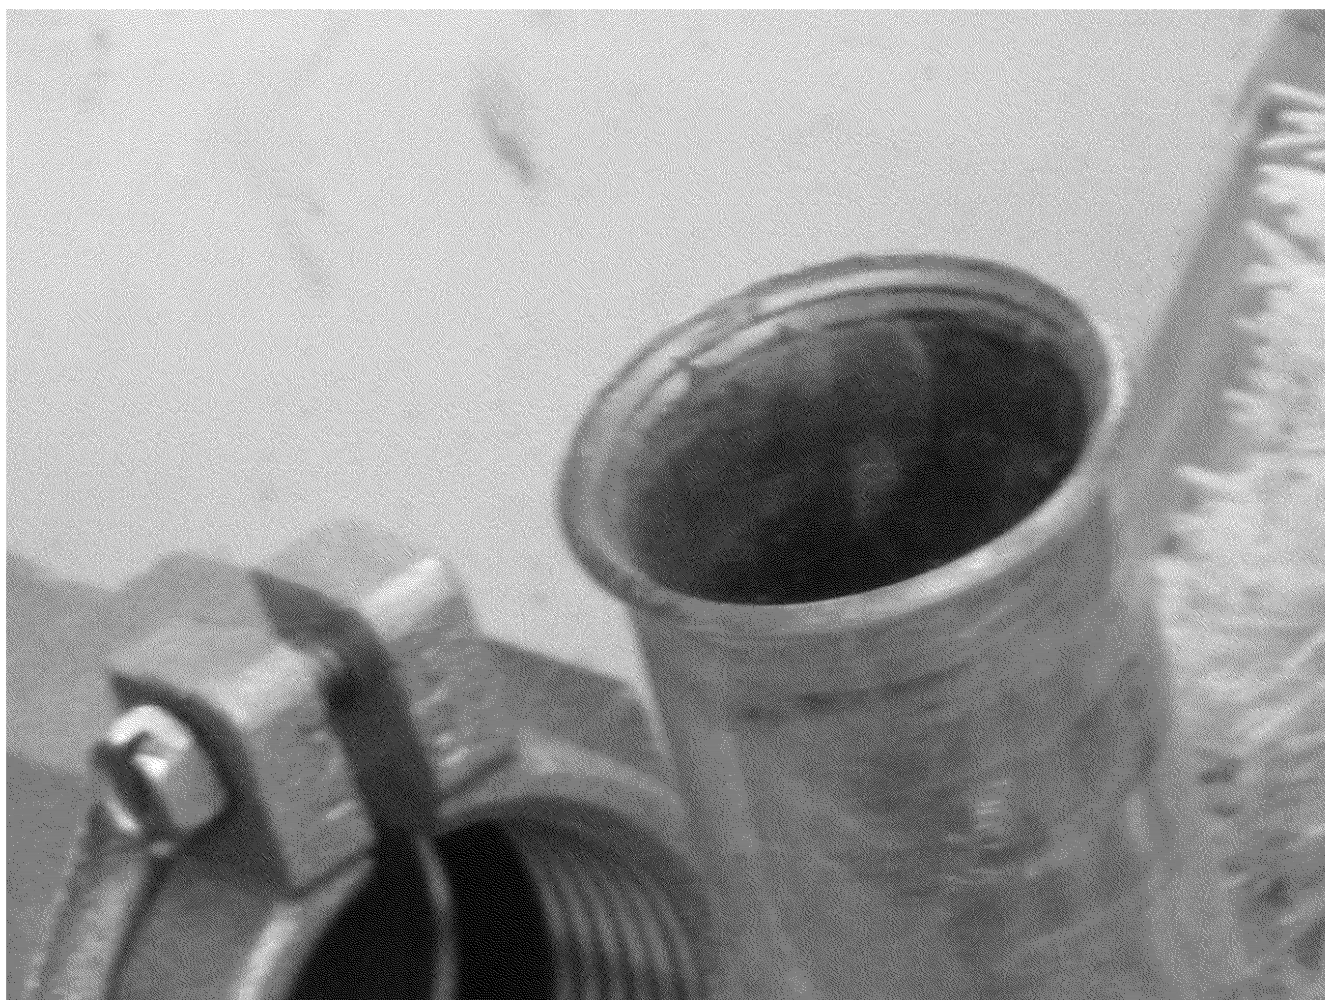
This is what the flared end of the copper tube looks like.

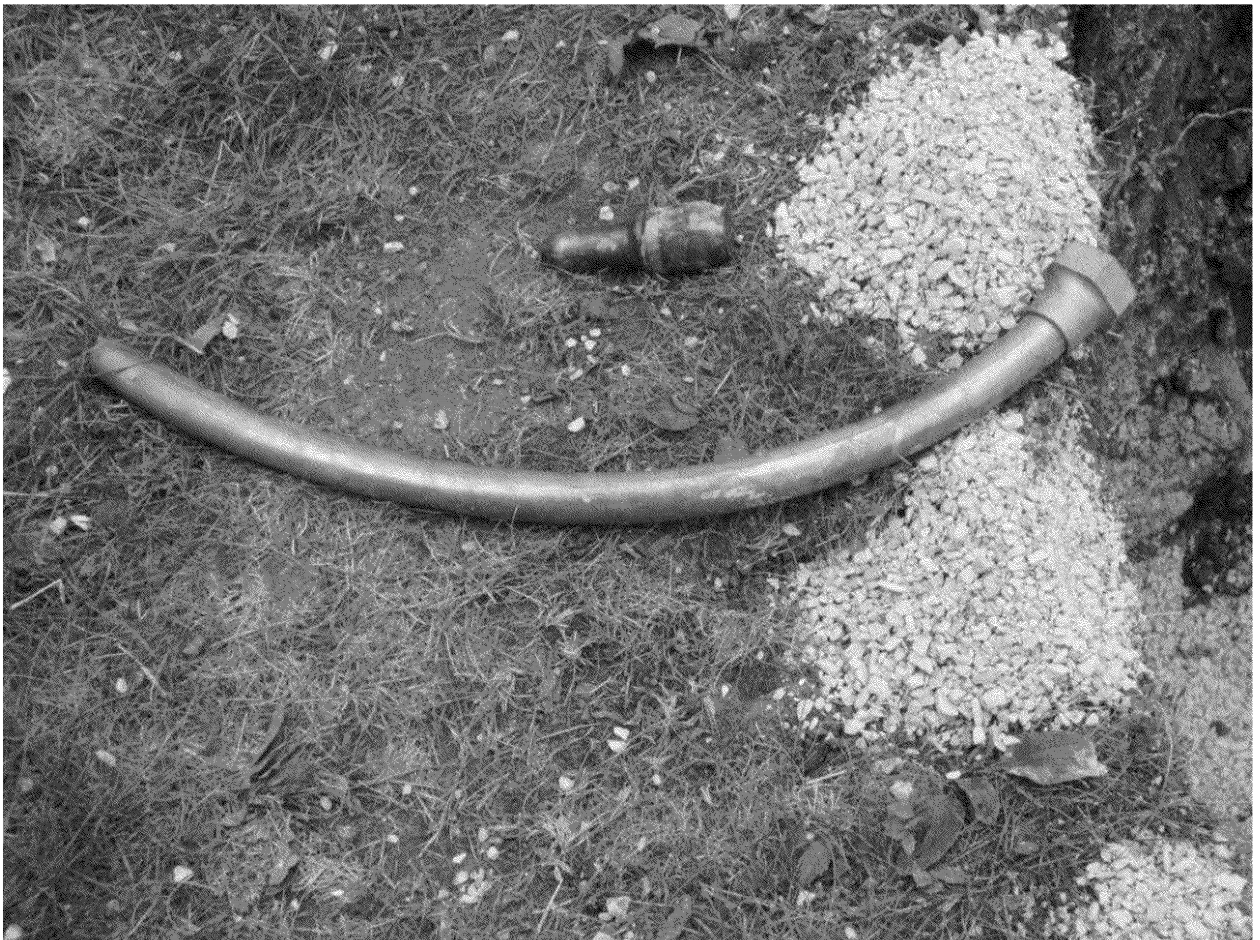
The copper pipe is ready to connect. The flaring tool is shown above. The other end of the copper tube will be flared in the trench.

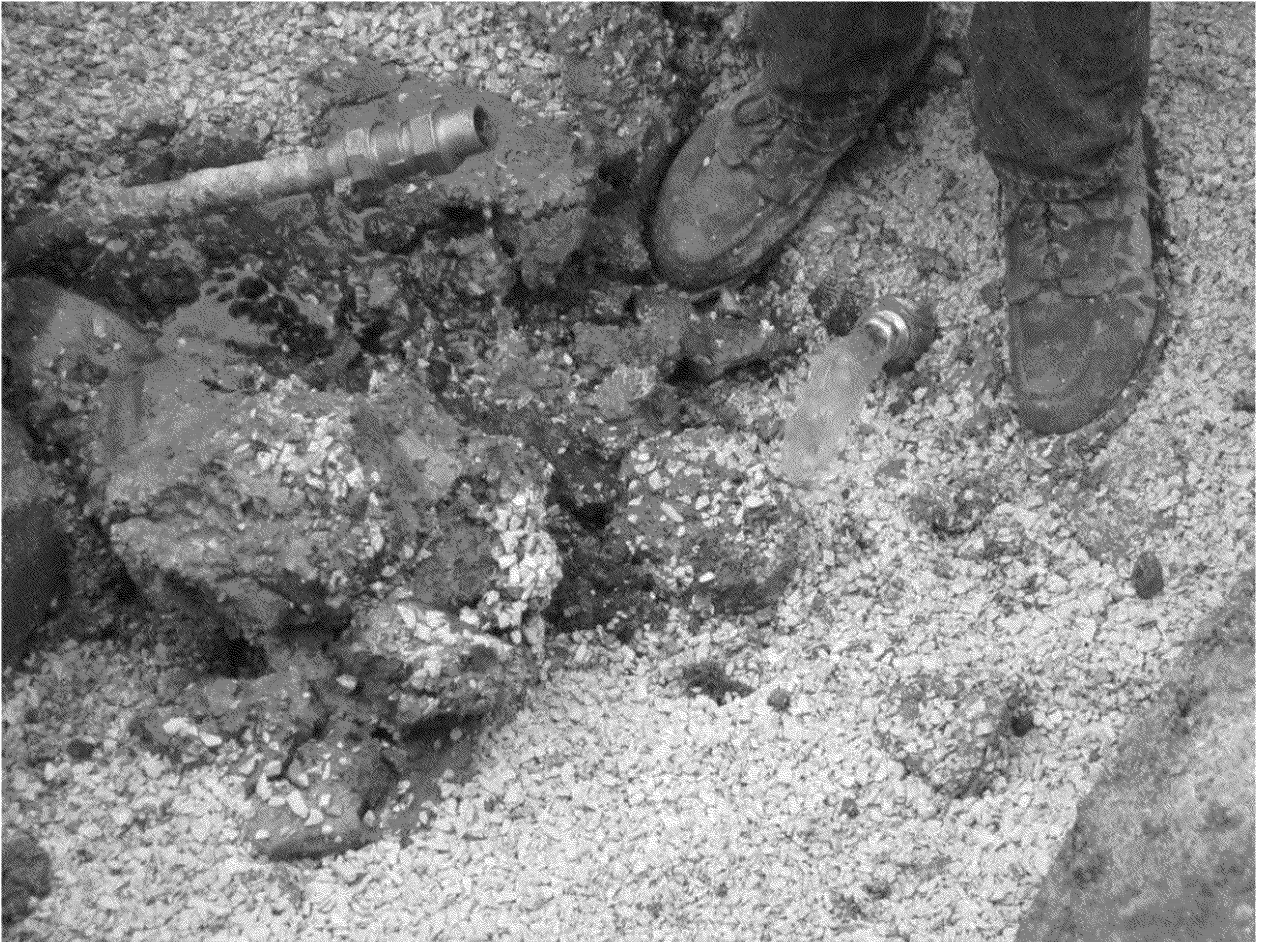
The valve on the new main is opened slightly to allow the water to run to clear any debris.

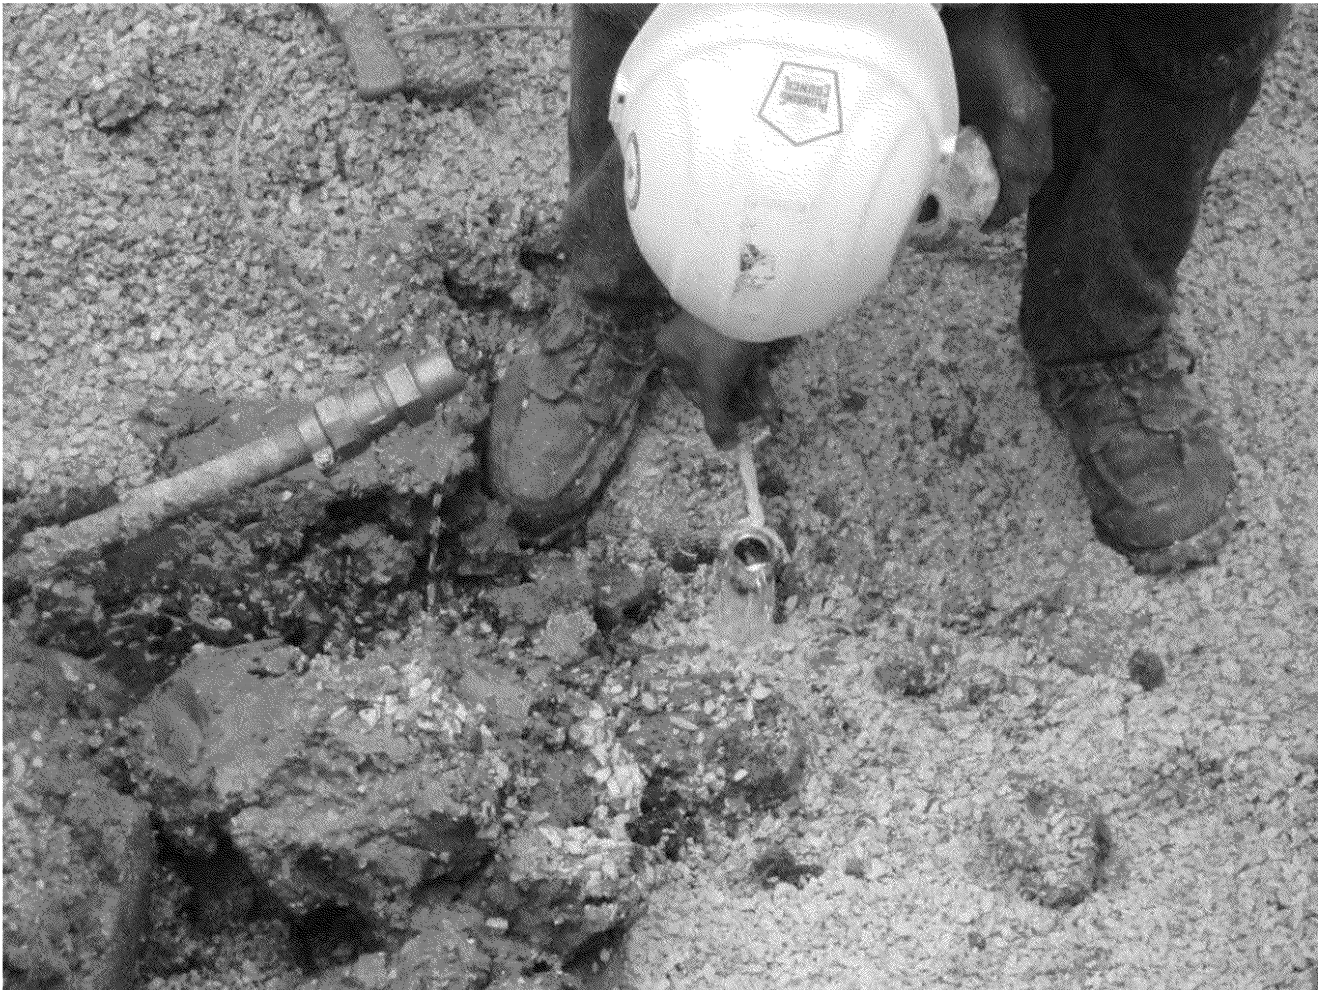
A thread sealer is applied while the water runs.

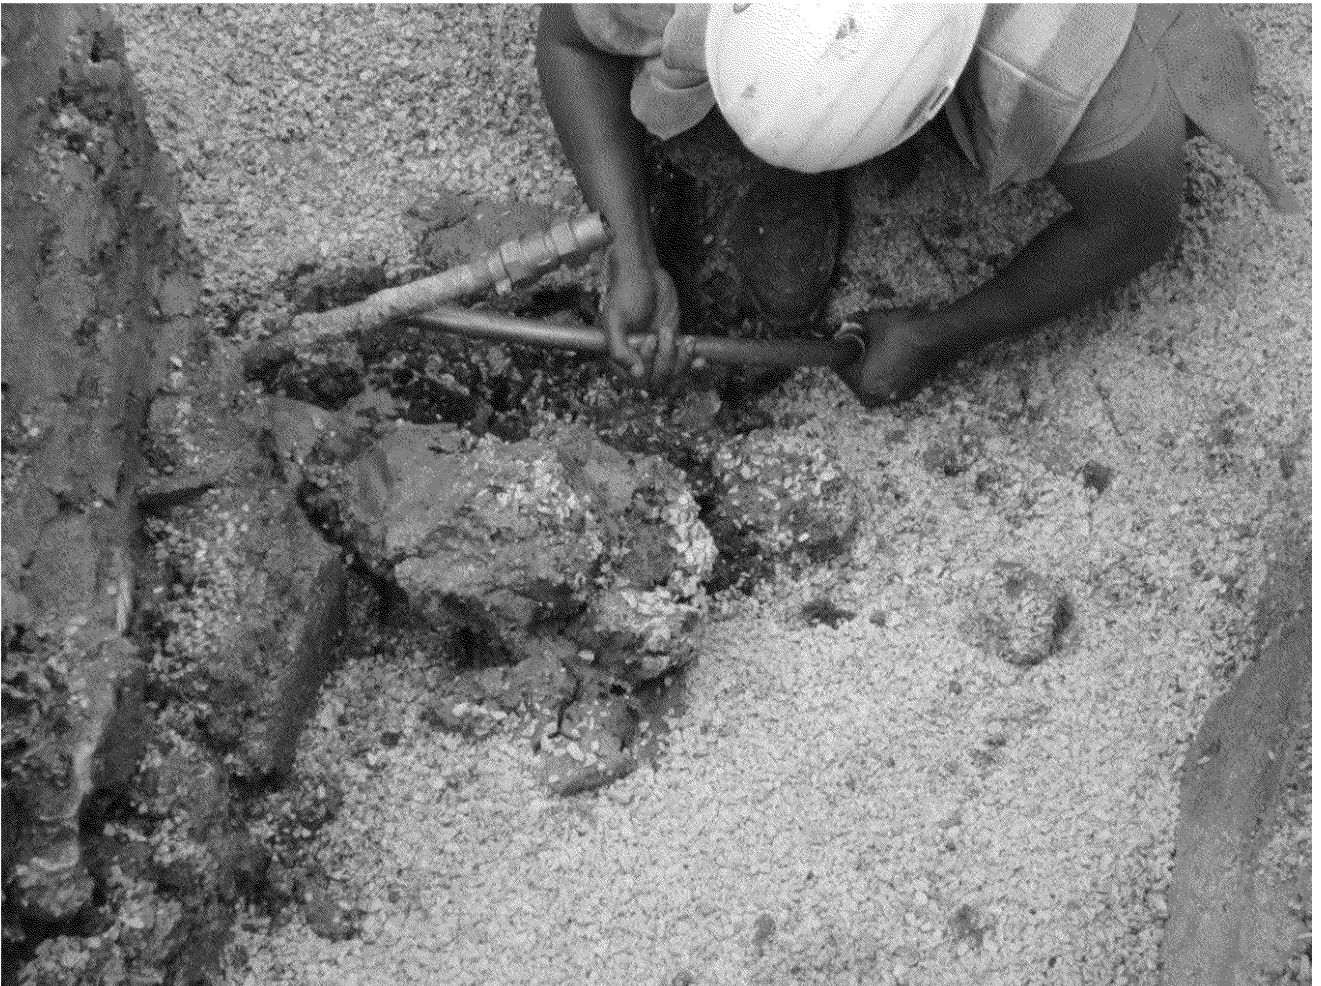
The copper pipe is too long to make the connection to the lead pipe and must be cut.

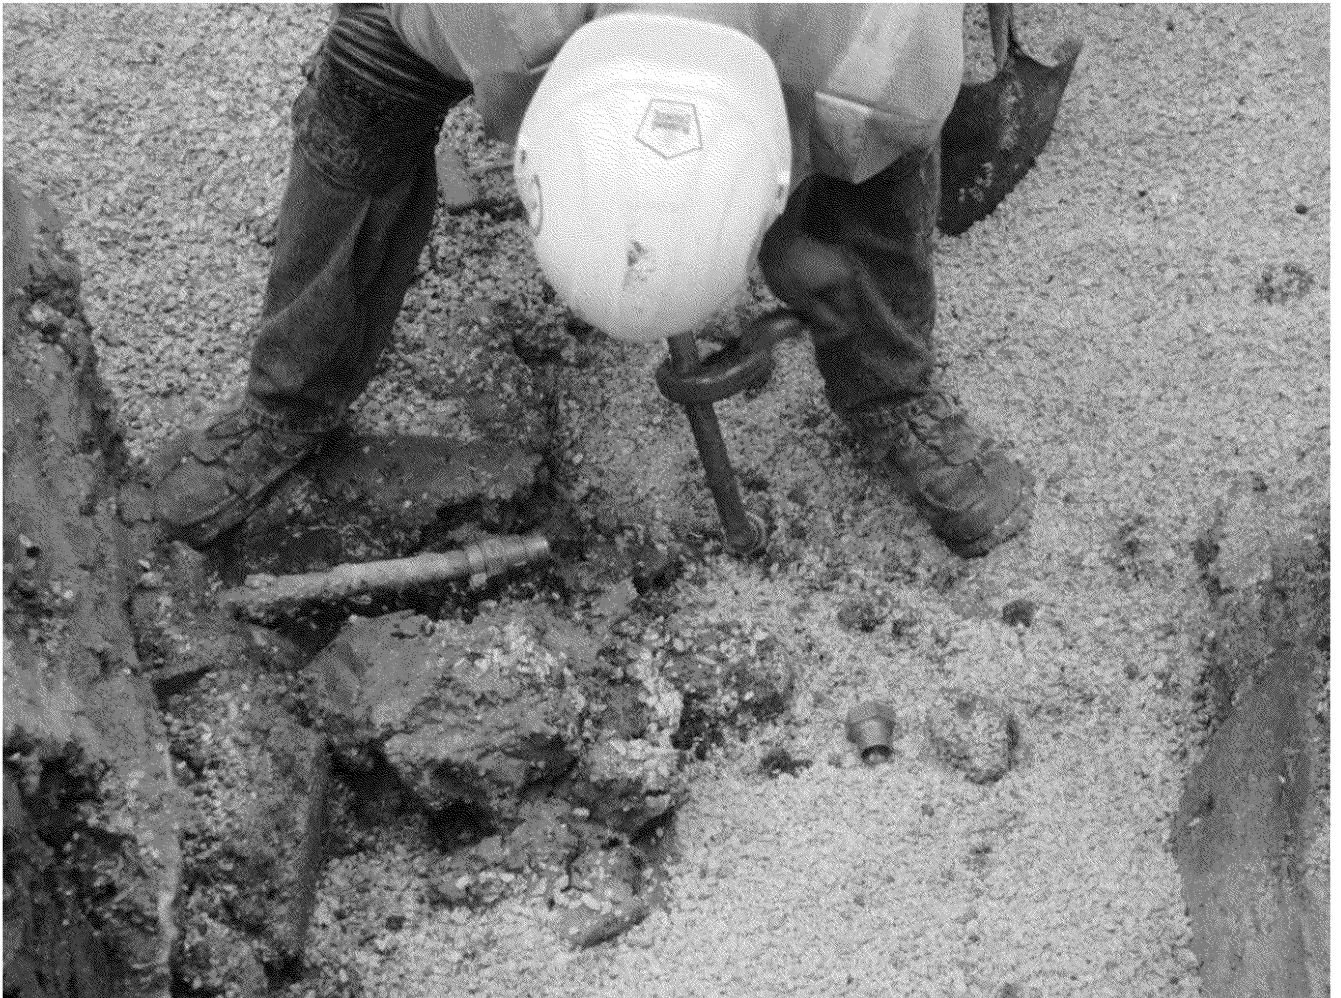
The copper pipe is cut using a rotary cutter.
